# Chicagoland Home & Building Inspections

**Charles Bellefontaine**  
1432 Sage Drive  
Bolingbrook, IL 60490

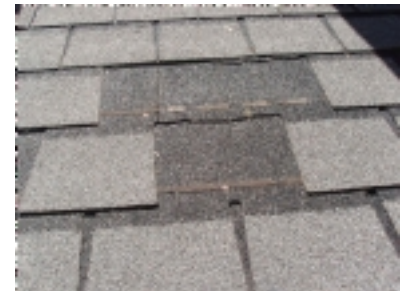
REPAIR or REPLACE - Shingles are missing on the north side of the house. In my opinion this can allow water leakage and water entry into the building. Water leakage can lead to various problems including damage to plaster, drywall, flooring and can lead to a mold problem. I recommend you contact a qualified roofing contractor for appropriate corrective action before water enters the building.

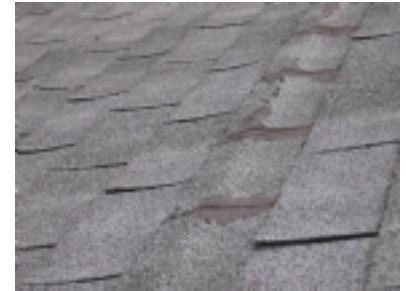
INFORMATION / MAINTENANCE - Patching is present on the east side of the garage. In my opinion this is considered a temporary repair. Patching suggests previous leakage or other problems and an attempt to correct. It may or may not hold up, its effectiveness is unknown. An annual inspection should be performed and repaired as needed.

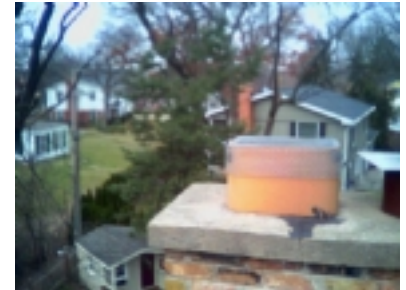
REPAIR or REPLACE - The chimney crown is cracked. In my opinion this may allow for water to enter and damage the brick, flue and chimney. I recommend that you contact a qualified chimney sweep to mitigate the situation.

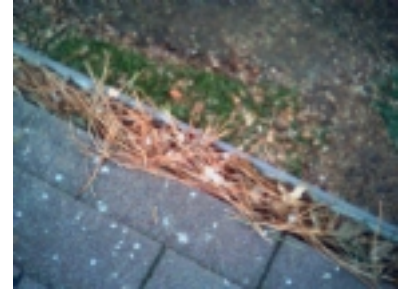
MAINTENANCE - Debris is blocking water flow from the gutters. In my opinion this can cause various damage including the increased potential for water leakage into the home if not corrected and cleaned out.

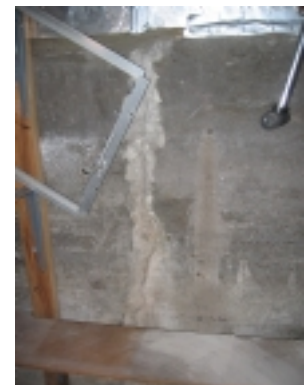
INFORMATION - A crack was found on the east wall that was filled with ejected epoxy. I recommend you request any and all information regarding these repairs. It is not within the scope of this inspection to determine the appropriateness or effectiveness of any repairs or their sustainability.

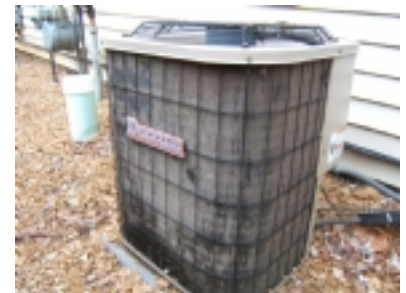
MAINTENANCE - The outdoor coil is dirty. This can reduce the efficiency of the air-conditioning system, cause performance problems, cause damages to the air-conditioning components and system, and lead to mechanical failure.

Appropriate corrective action is needed by a qualified mechanical contractor before any damage can occur.
